Port of Seattle
Terminal 108

Preliminary Assessment Report

February 2019
REVISED FINAL

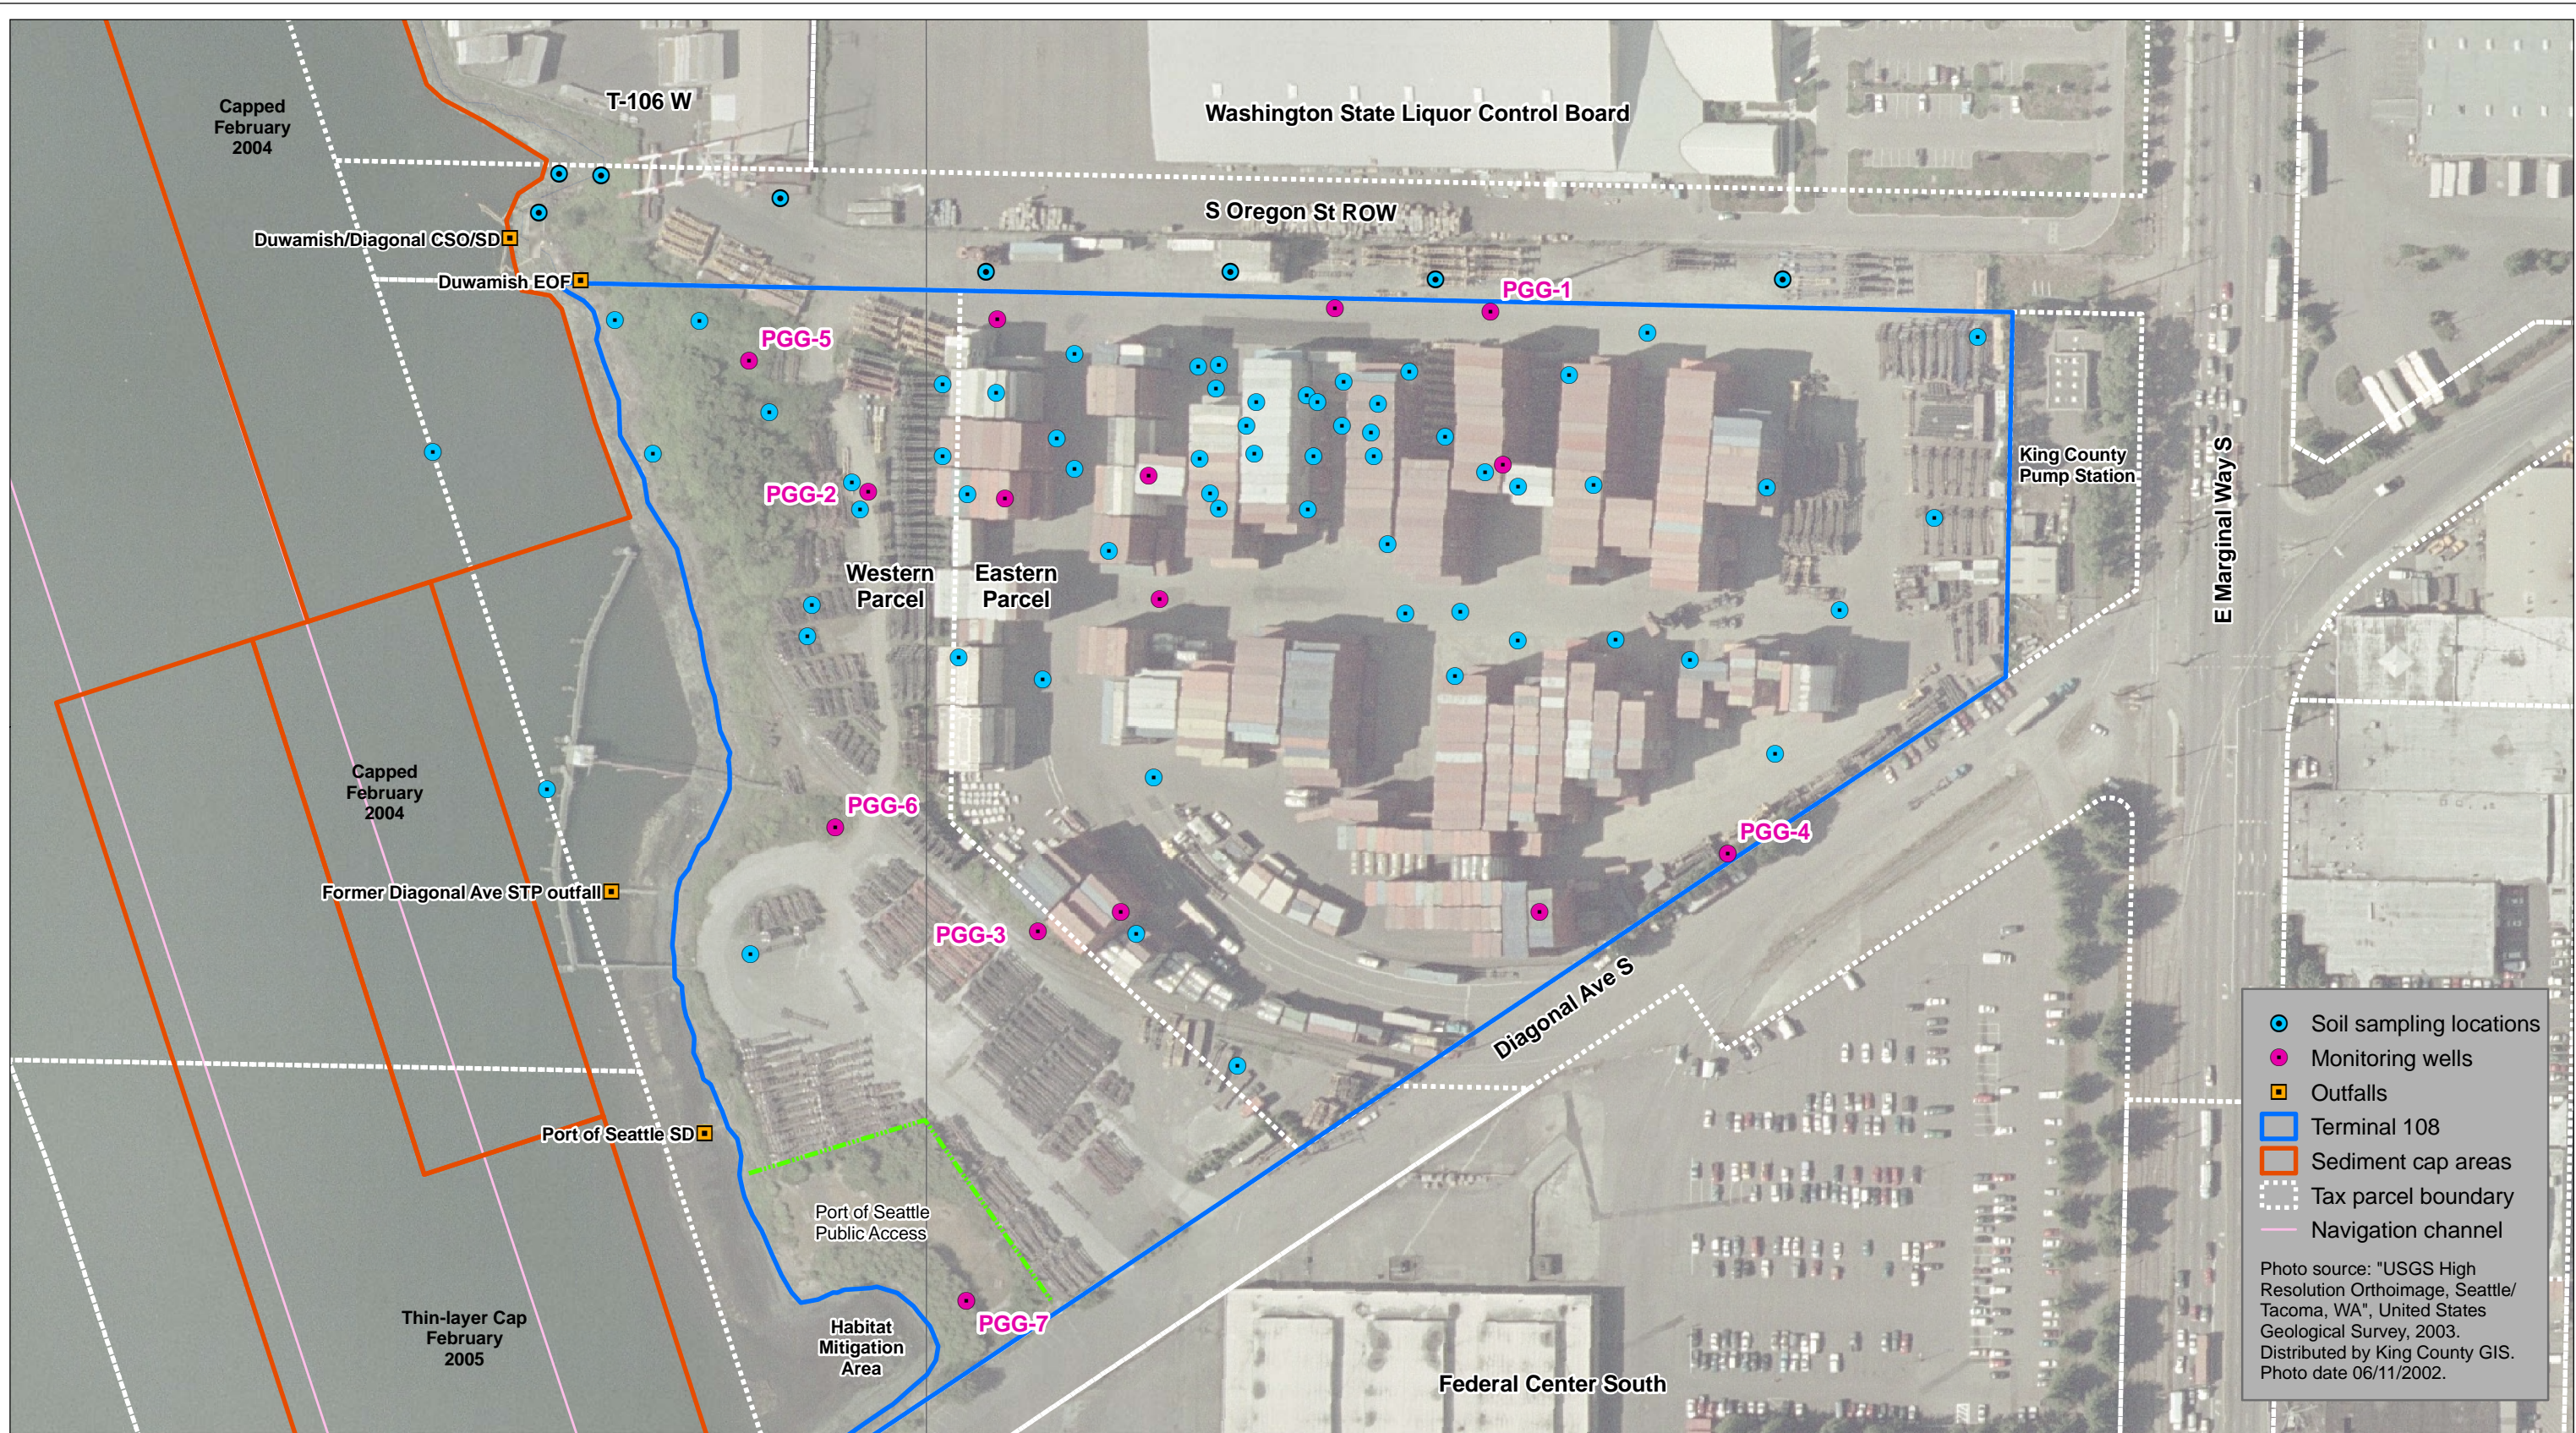
Map 3. Groundwater well and soil sampling locations

The fill layer discussed in Section 2.3.1 is the uppermost water-bearing unit of the subject property. This unit is often referred to as the shallow aquifer in investigation documentation. Monitoring wells installed on T-108 have been completed in this shallow aquifer unit (Appendix A, Photo 6 is a representative groundwater well at T-108); groundwater is typically observed in this unit at approximately 10 ft bgs. Groundwater near the LDW within this shallow unit is tidally influenced. Groundwater flow patterns in the shallow aquifer have been observed over the course of several years of investigation; groundwater appears to flow radially from a relative high in the north-central portion of the subject property (roughly between groundwater monitoring wells PGG-1 and PGG-2 on Map 3).

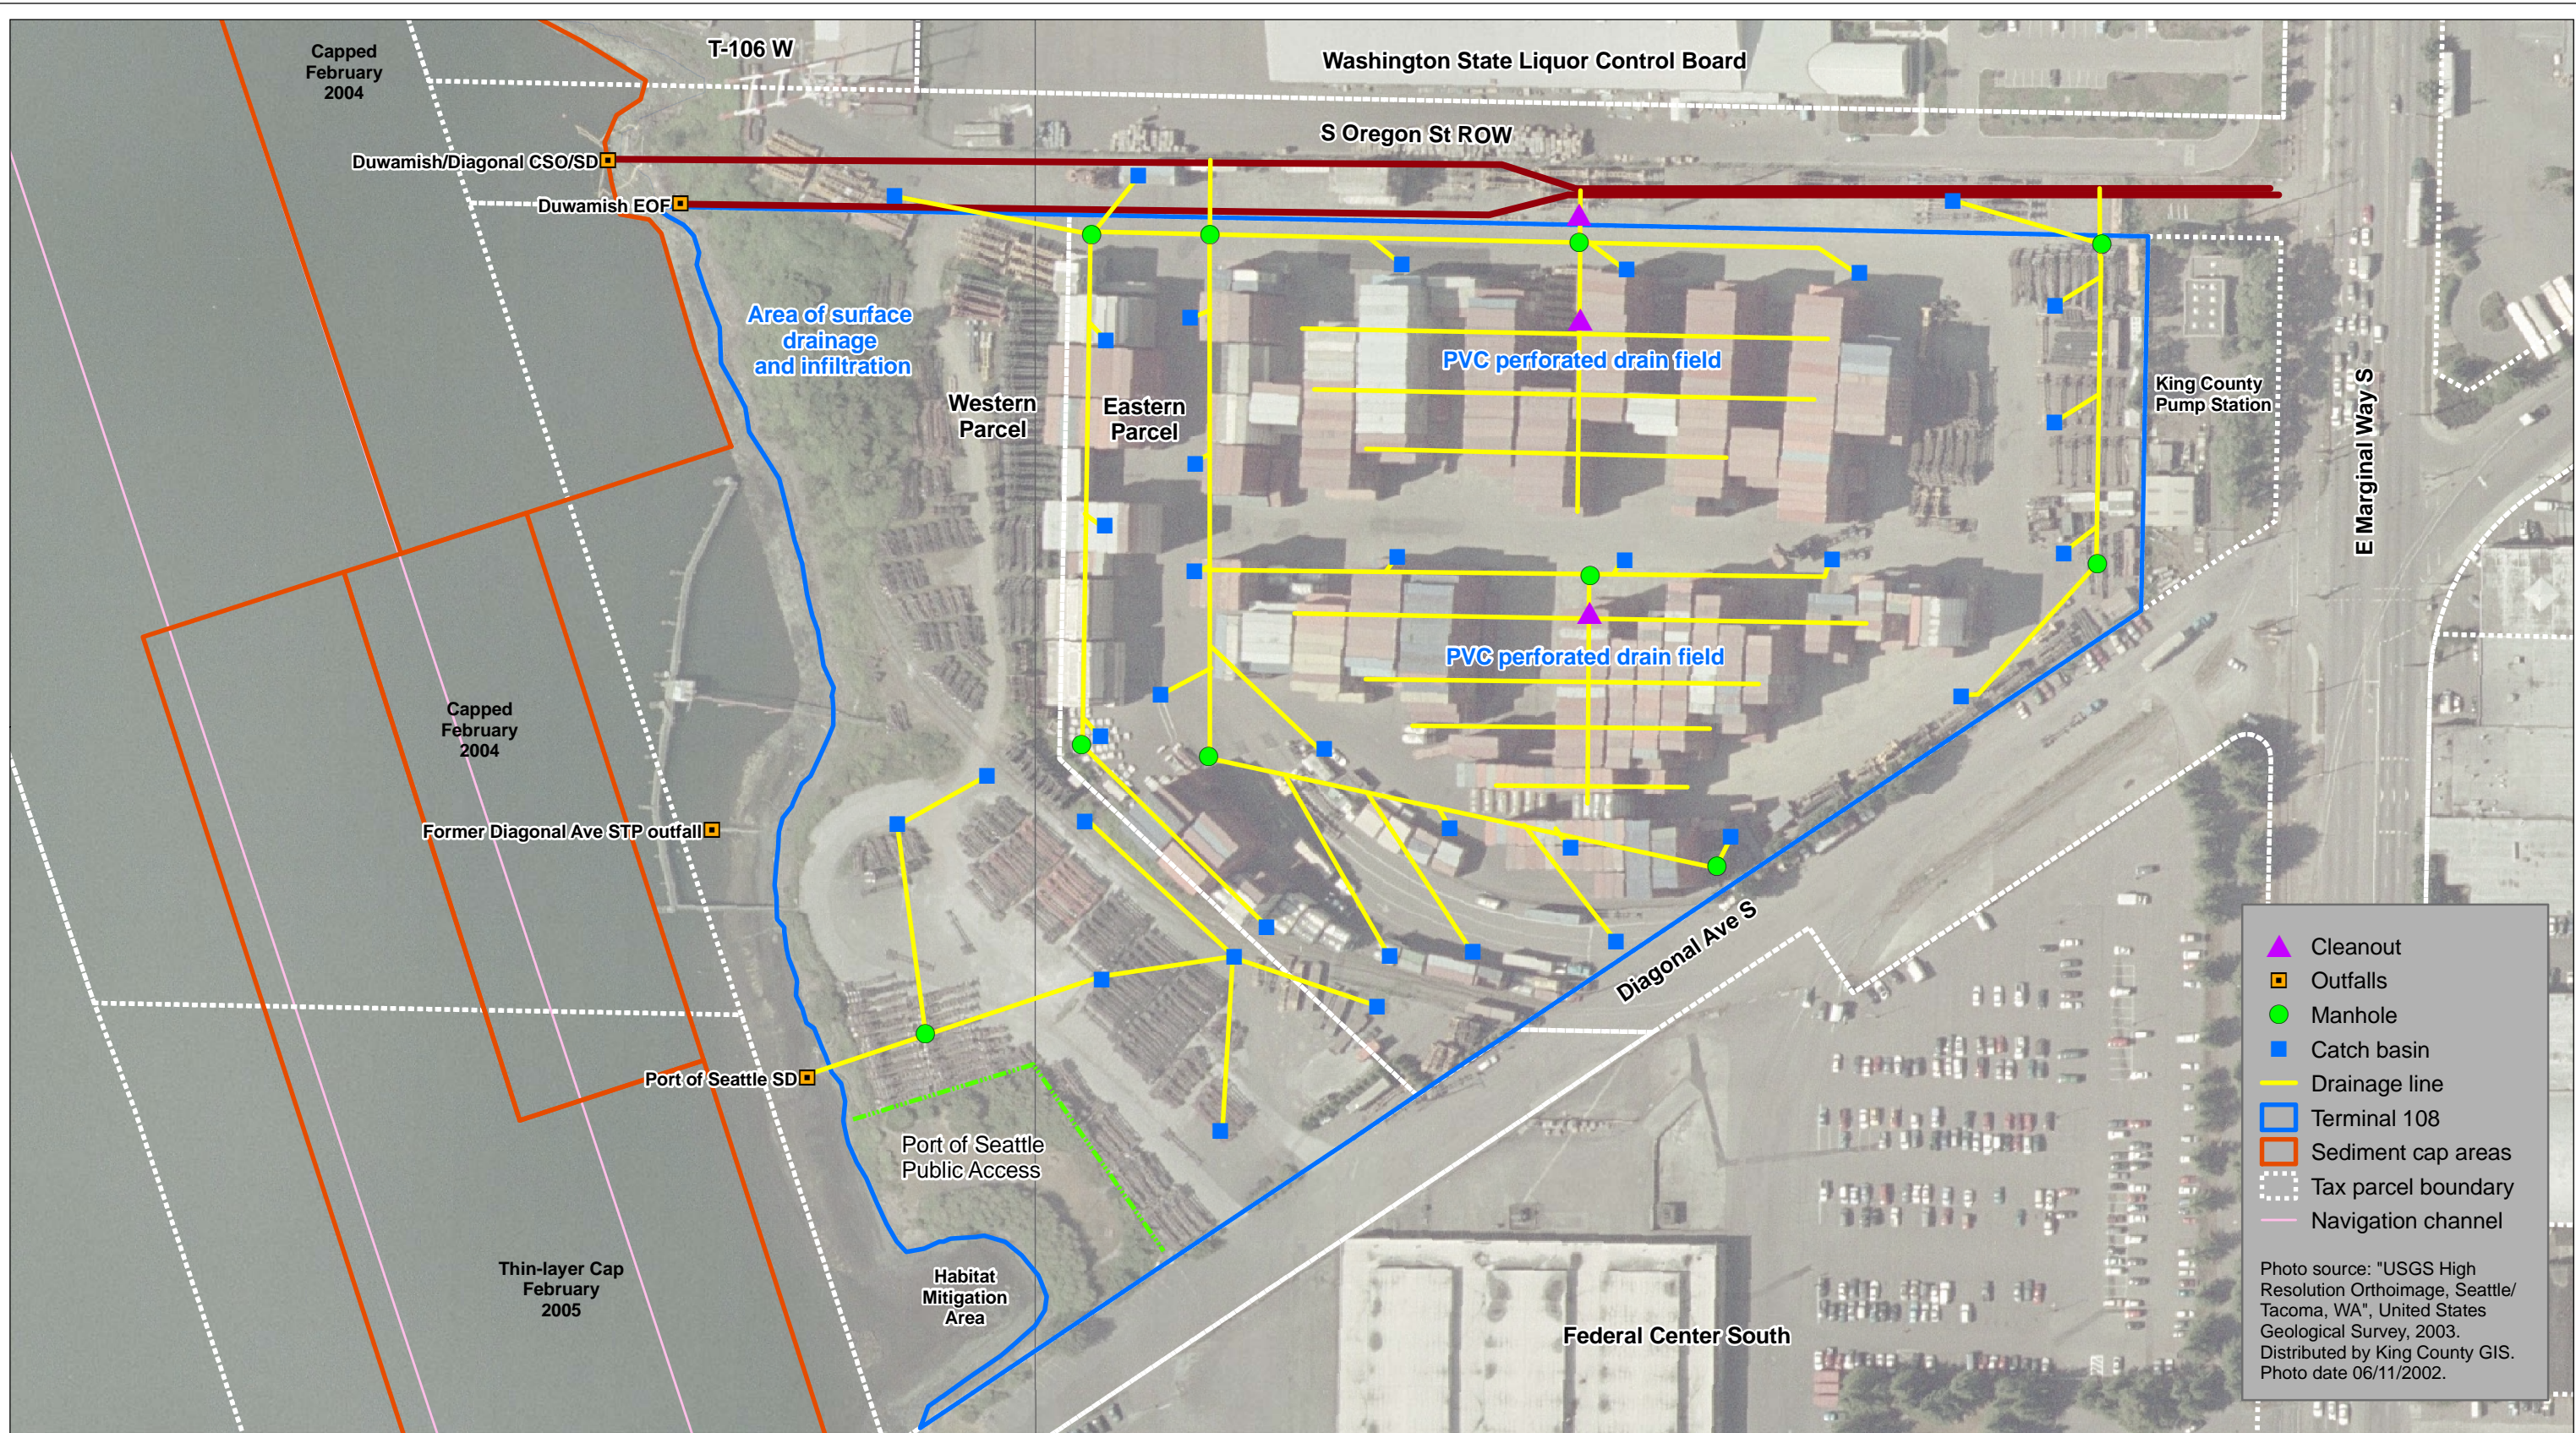
Map 5. Stormwater drainage networks

Improvements on the Western Parcel of T-108 are primarily associated with its former uses. The southern portion of the Western Parcel was paved in the early 1960s for use as a parking lot (Port of Seattle 1988). A drainage system consisting of catch basins and a storm drain (Port outfall 2225) was also installed at this time to drain stormwater from the parking lot (Map 5).

In the early 1990s, Lafarge Canada, Inc. (Lafarge) installed a bulk cement terminal on the Western Parcel. The terminal was installed on existing paved areas (a former parking lot) which drained to an existing SD outfall. A catch basin was installed by Lafarge for the truck wash-down area; this catch basin was plumbed to the sanitary sewer (Port of Seattle 1988). The paved areas and catch basins, as well as remnants of the truck wash-down area, remain on the Western Parcel. In addition, Lafarge constructed a pier and pneumatic conveyor system offshore of T-108 in approximately the center of the shoreline. These features are still present although not currently in operation (Map 2).

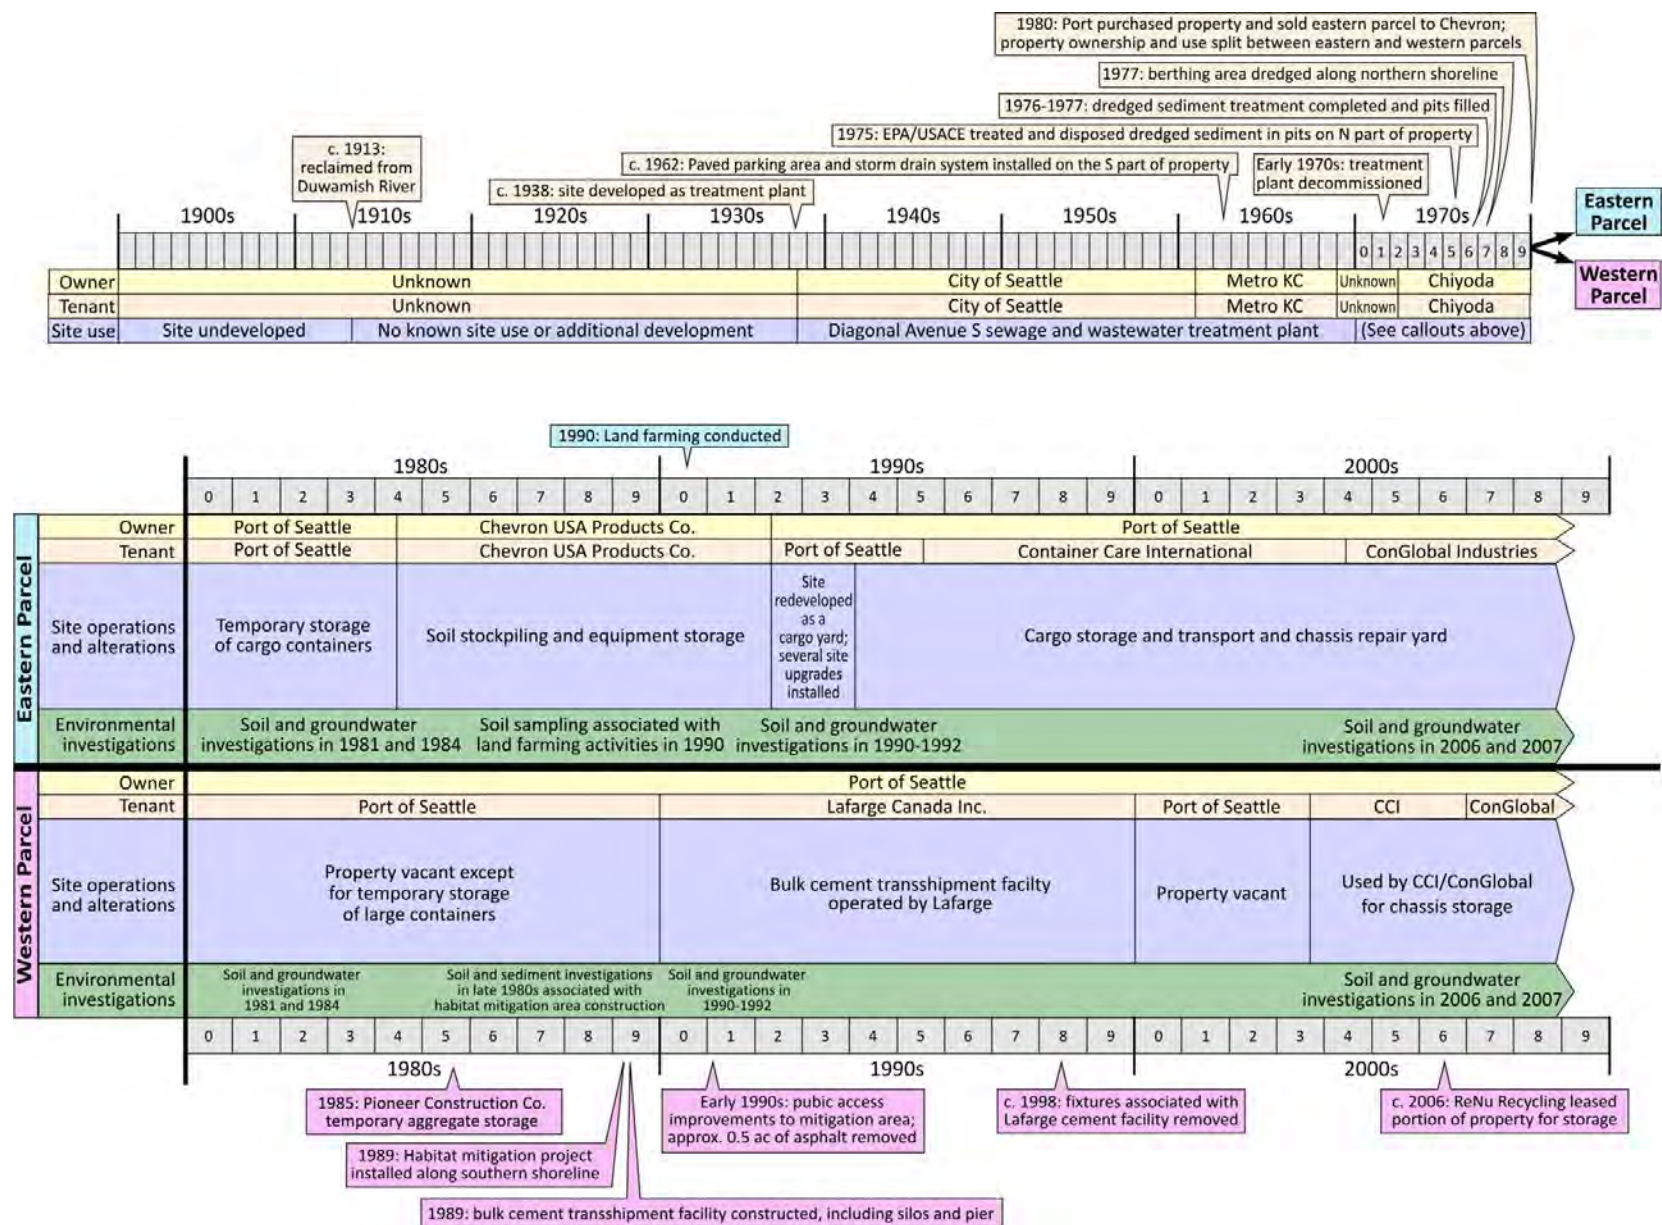
Figure 1. T-108 timeline: ownership, operations, and environmental investigations

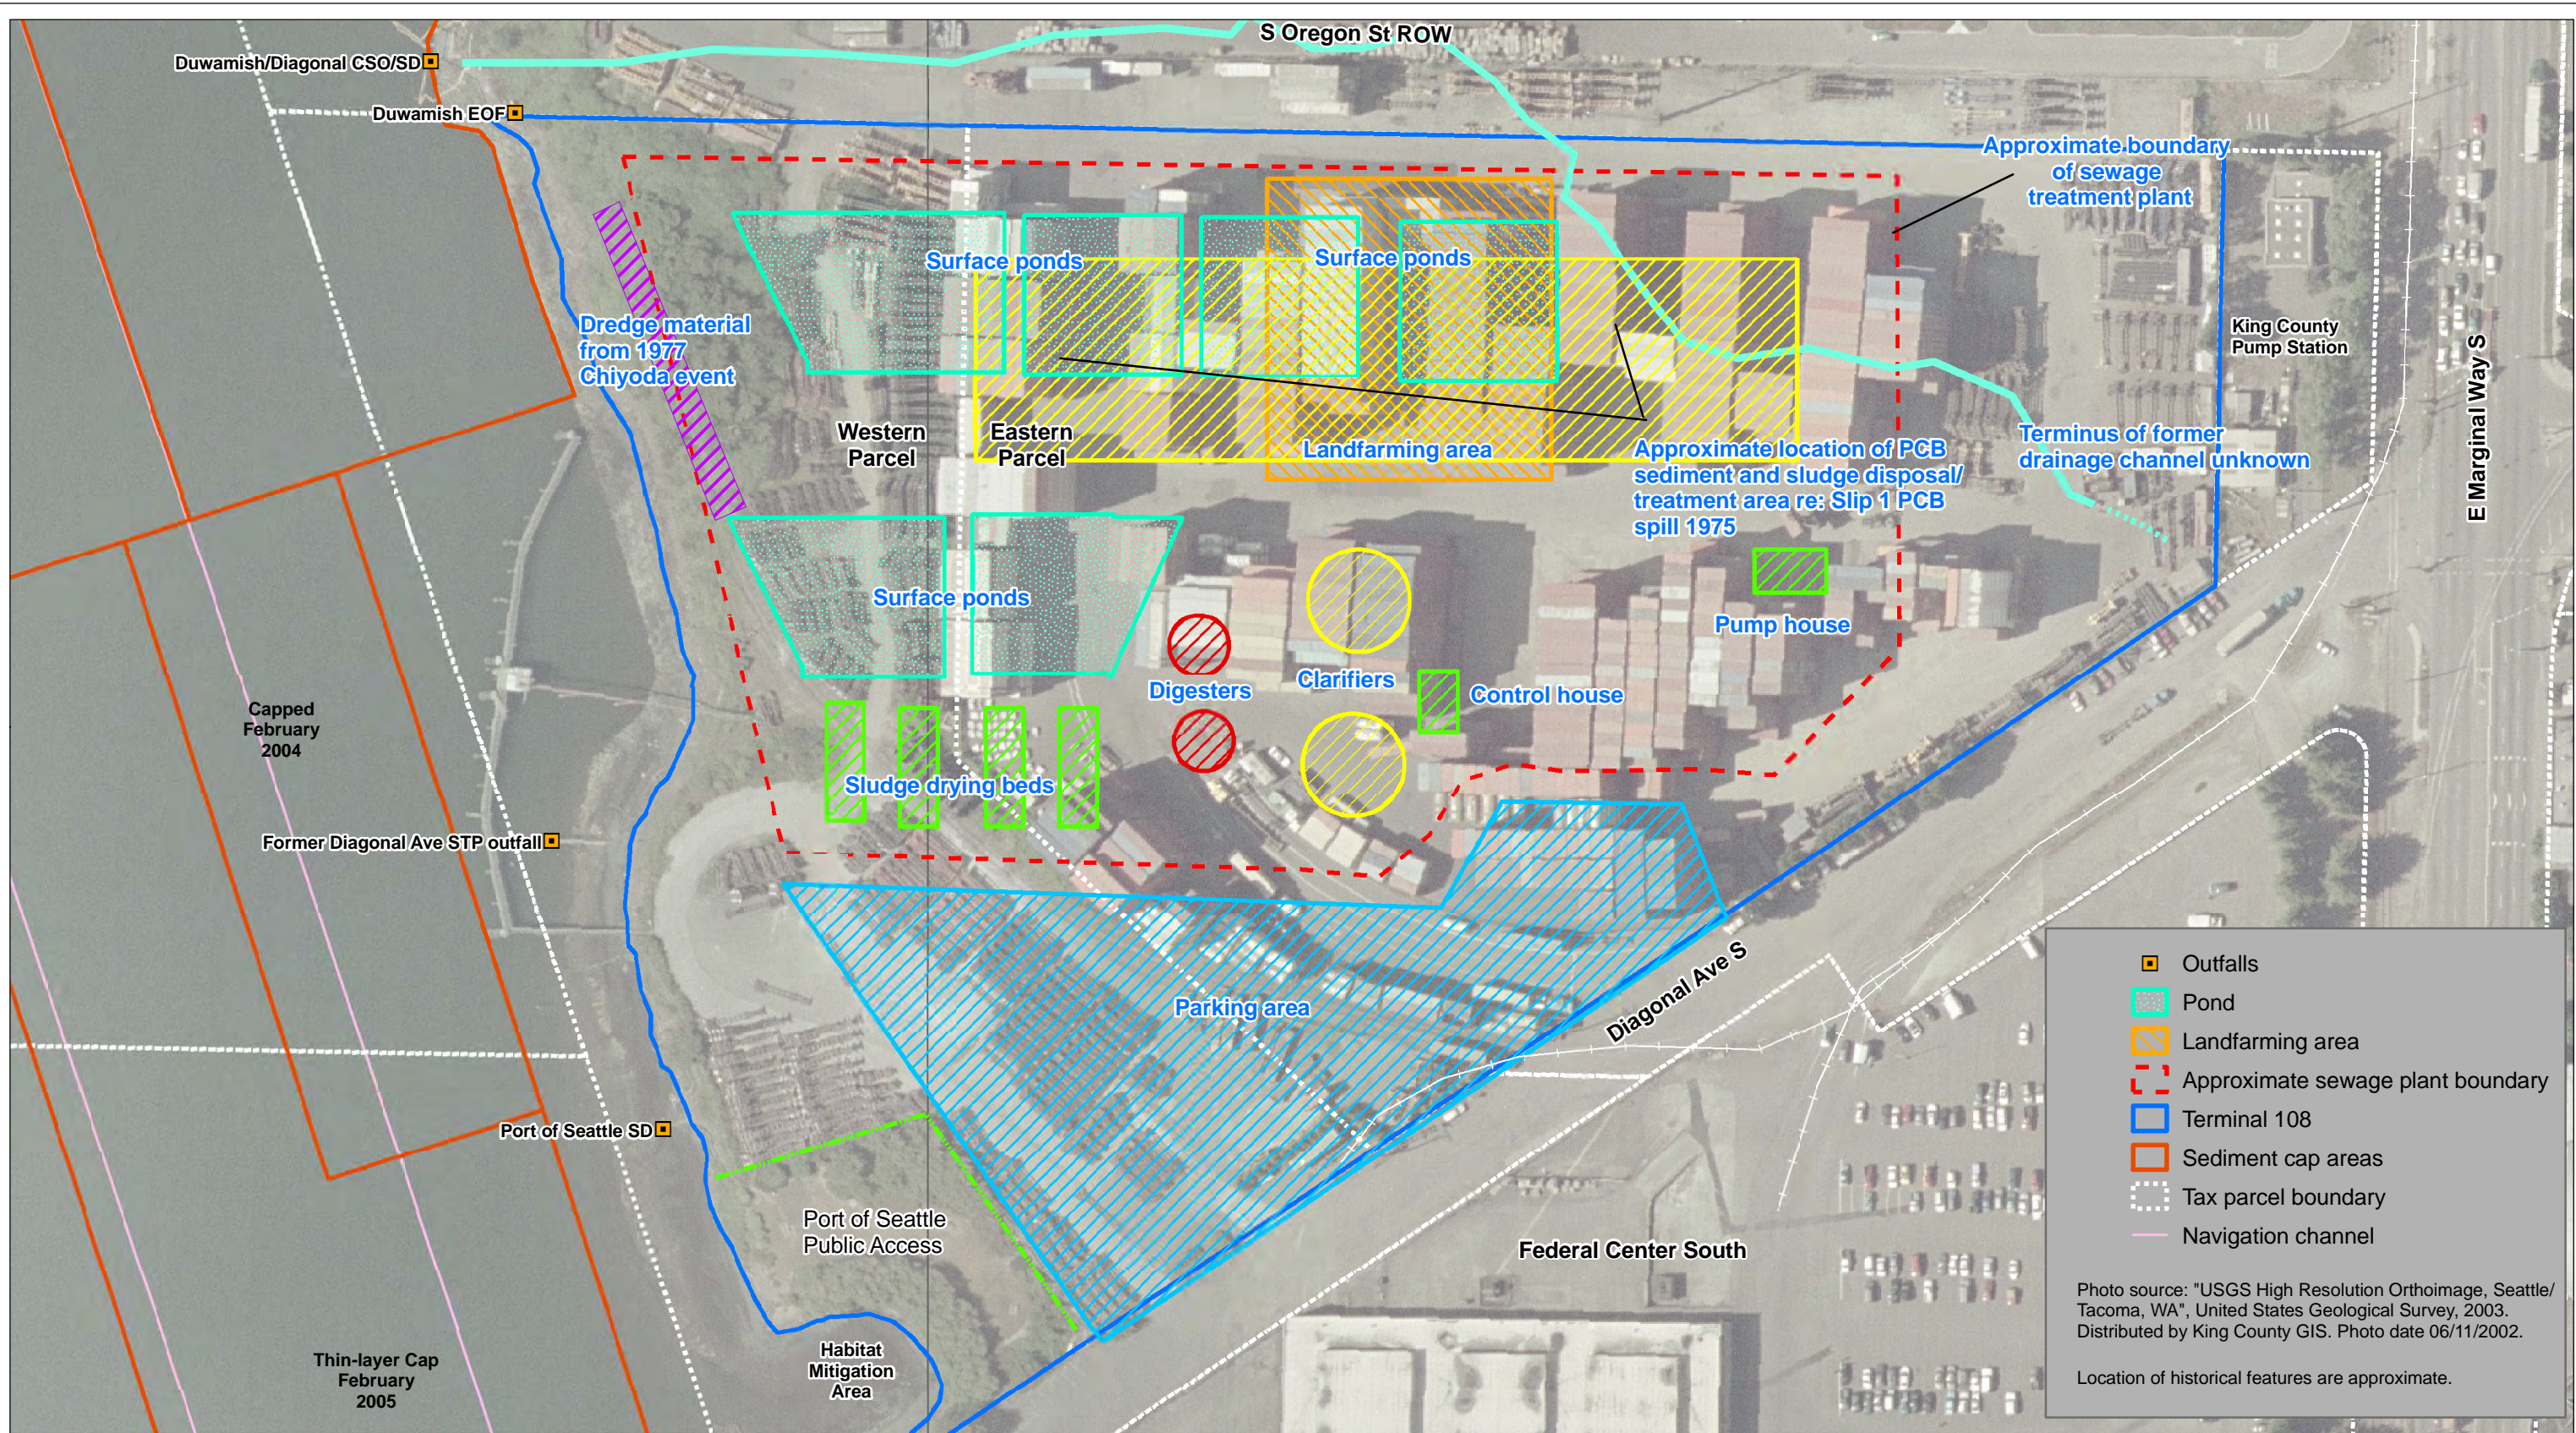
Map 8. Historical Site Features Overlay

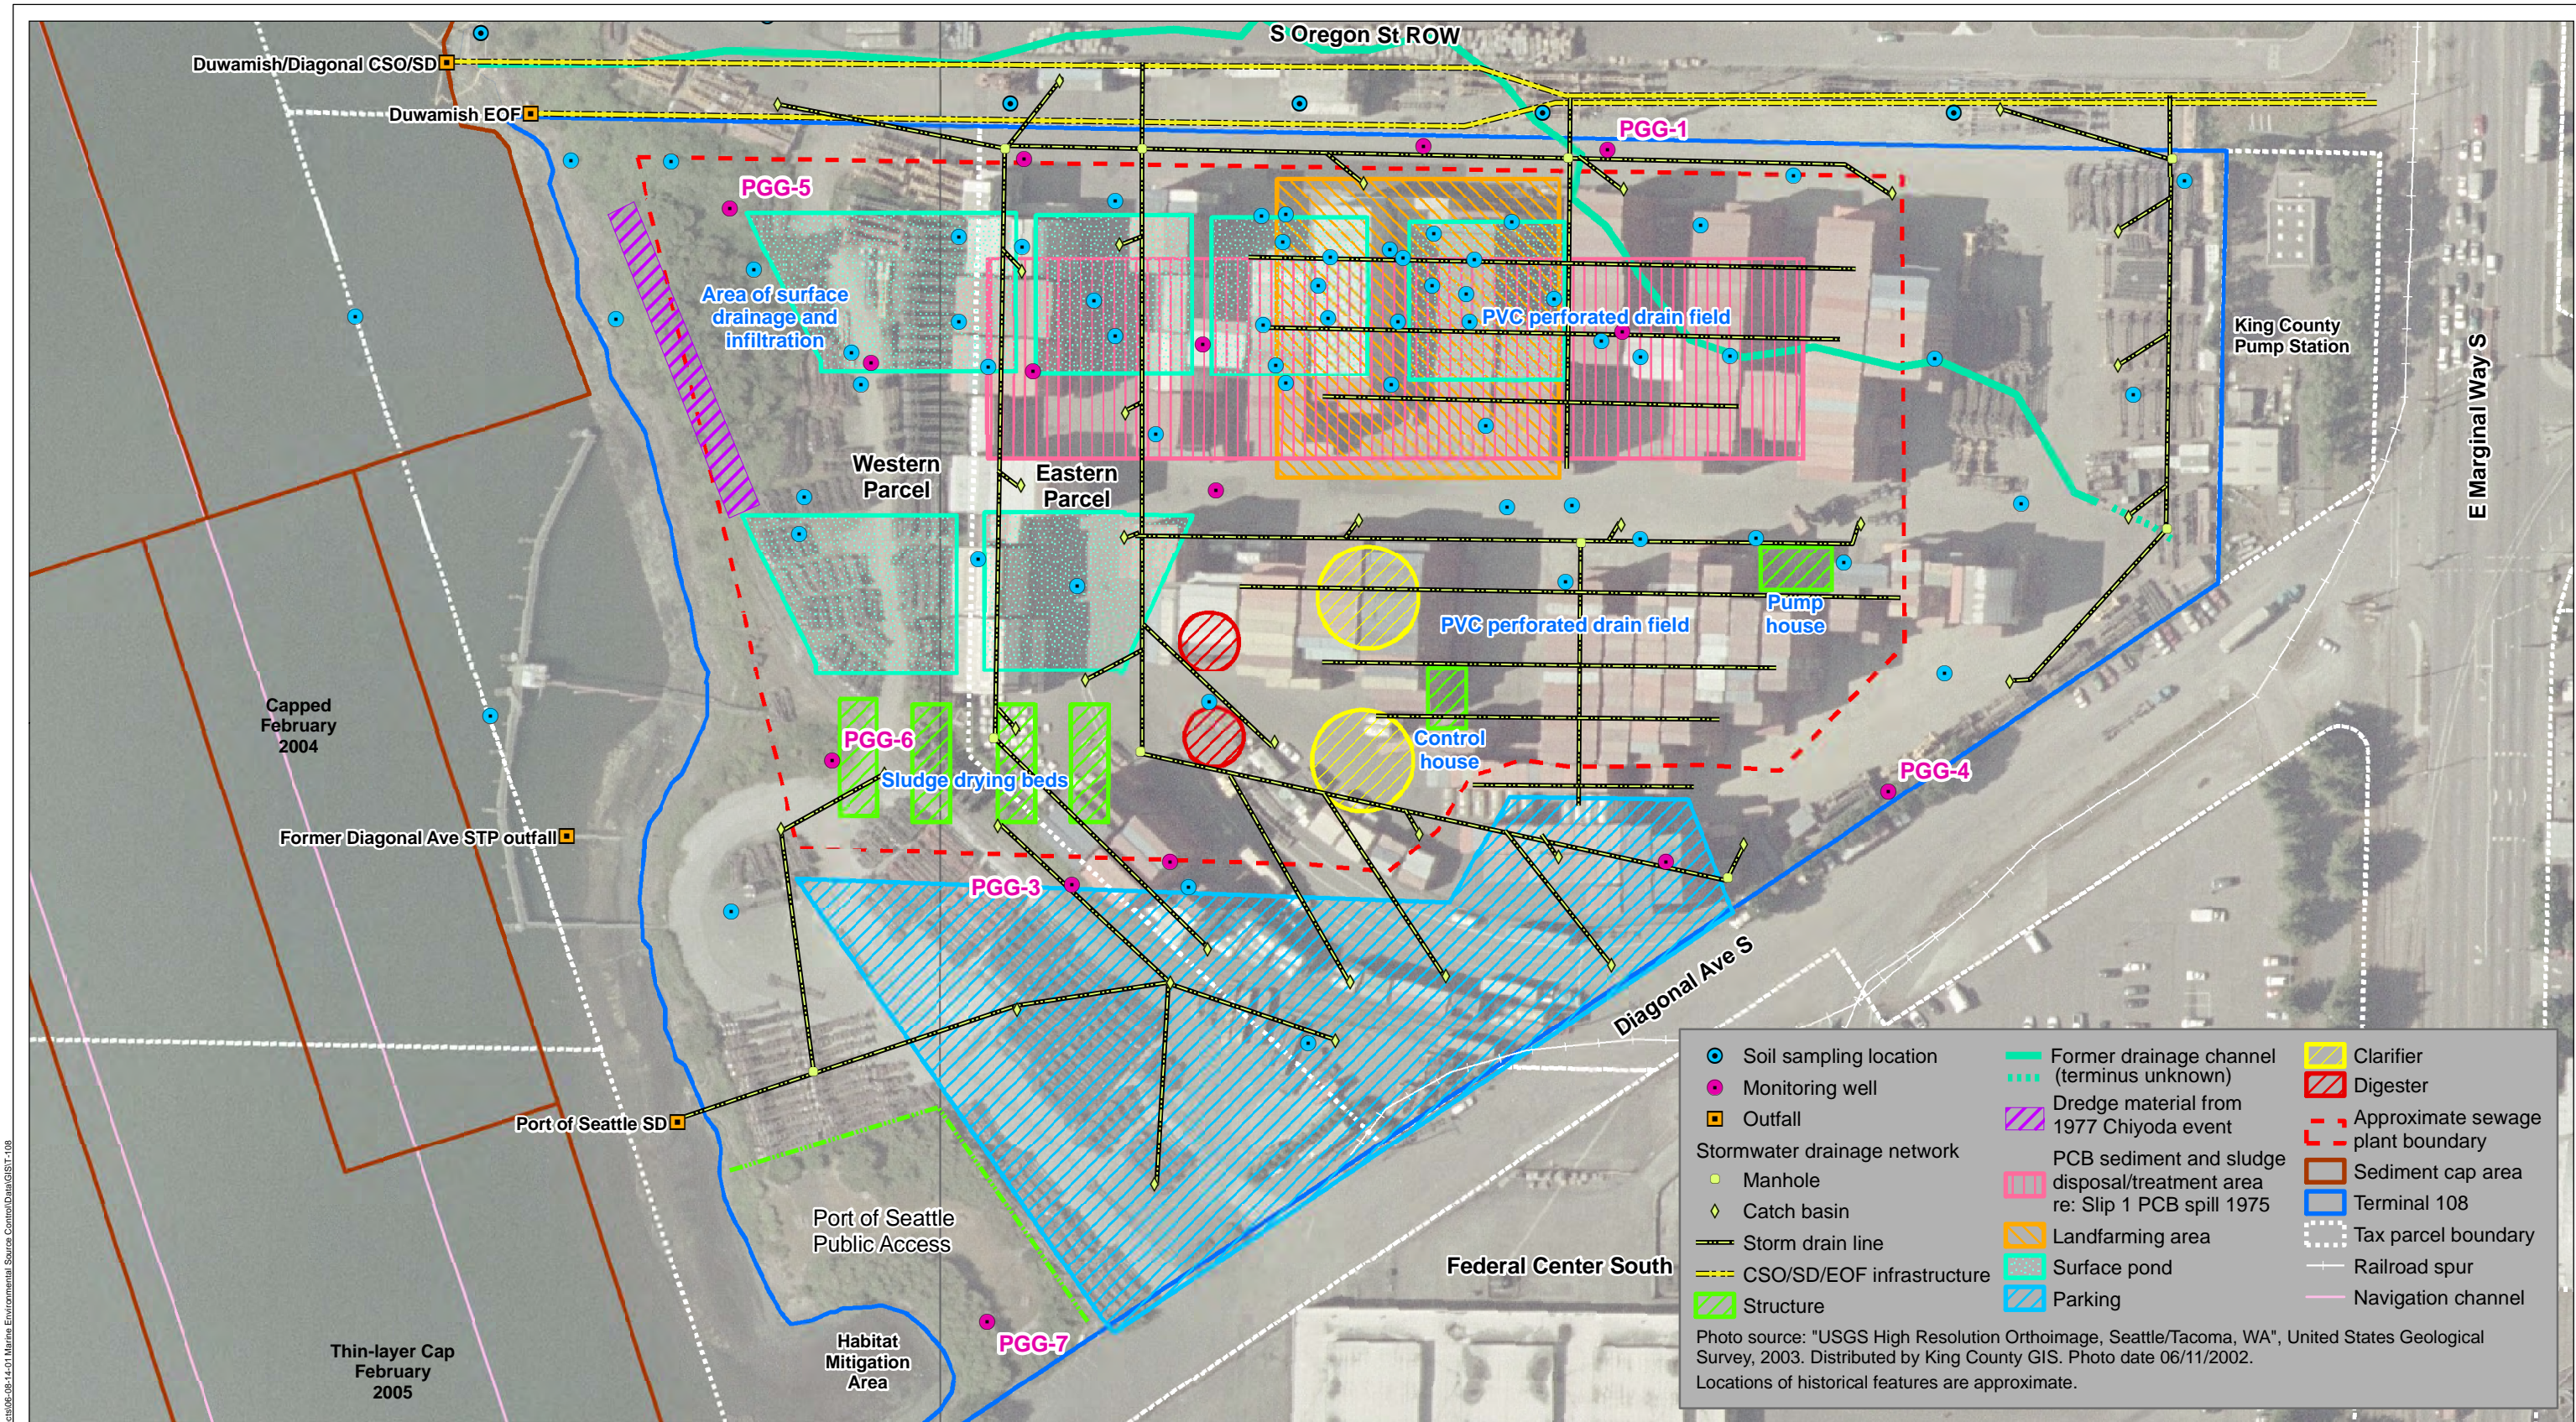
Map 9. Historical site feature overlay, previous sample locations, and current drainage features

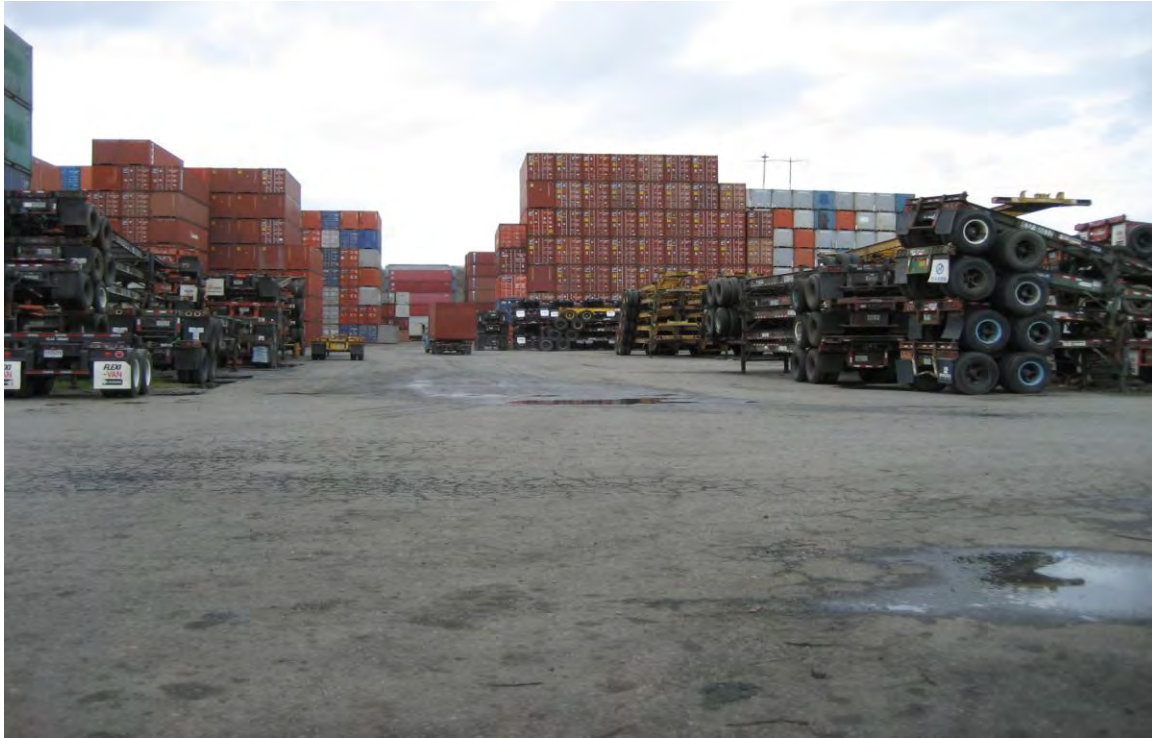
Photo 1: ConGlobal Industries container terminal operations on the eastern parcel of T-108.

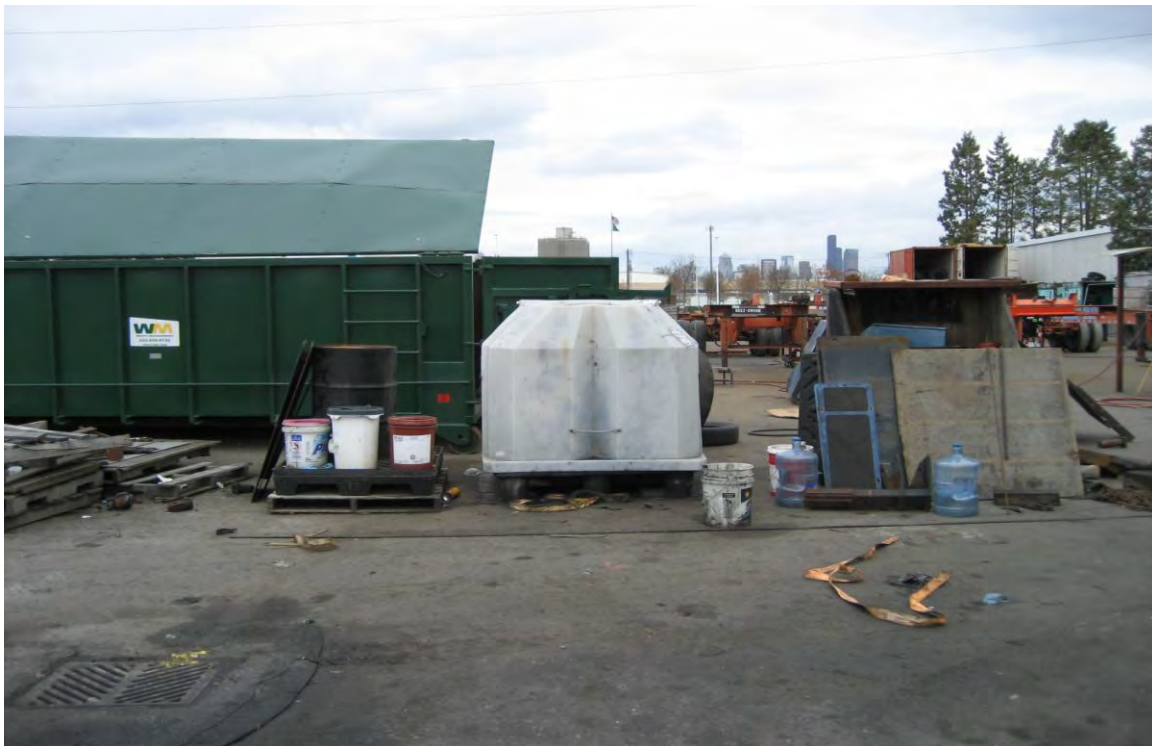
Photo 2: View (looking north) of the maintenance area located on the eastern portion of the ConGlobal Industries container terminal.

ConGlobal is currently the only tenant at T-108, and the company continues to operate a container terminal on the Eastern Parcel. Containers are stored throughout the Eastern Parcel and maintenance is conducted on the eastern end of the parcel (Appendix A, Photo 2). A fueling area, which includes two aboveground storage tanks (AST) containing diesel (one 300-gallons and one 600-gallons) is located on the southern portion of the Eastern Parcel. An additional 1,200-gallon AST is also located in this area.

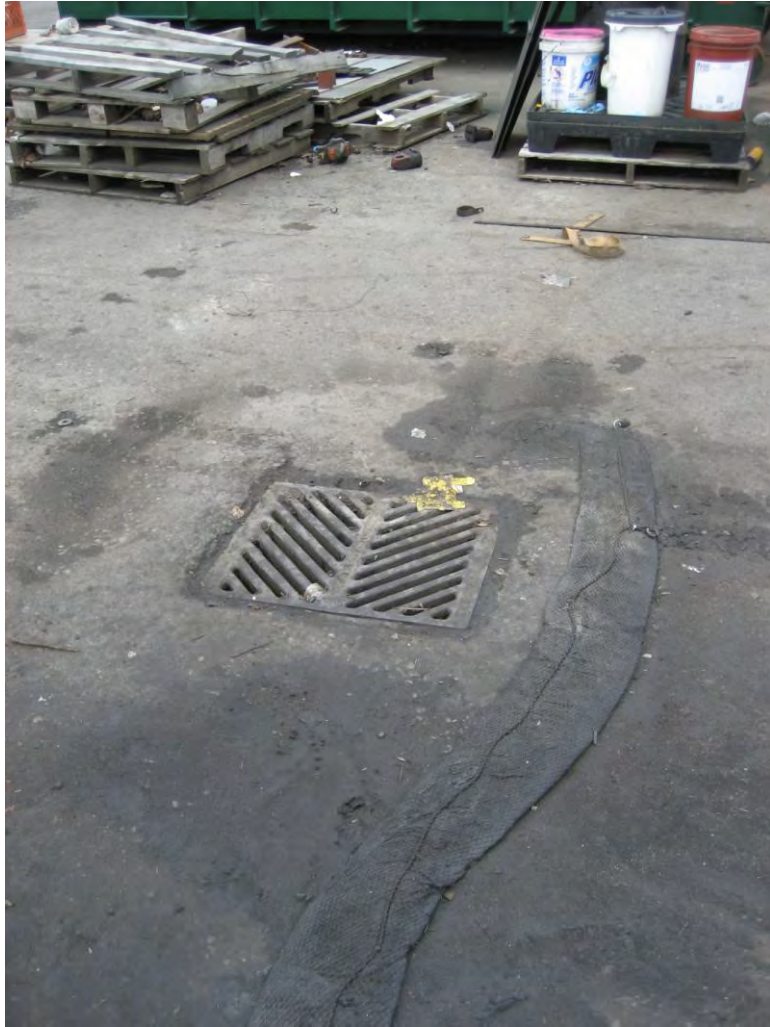
Photo 3: A catch basin on the northern portion of the ConGlobal Industries container terminal located near the maintenance area (eastern parcel).

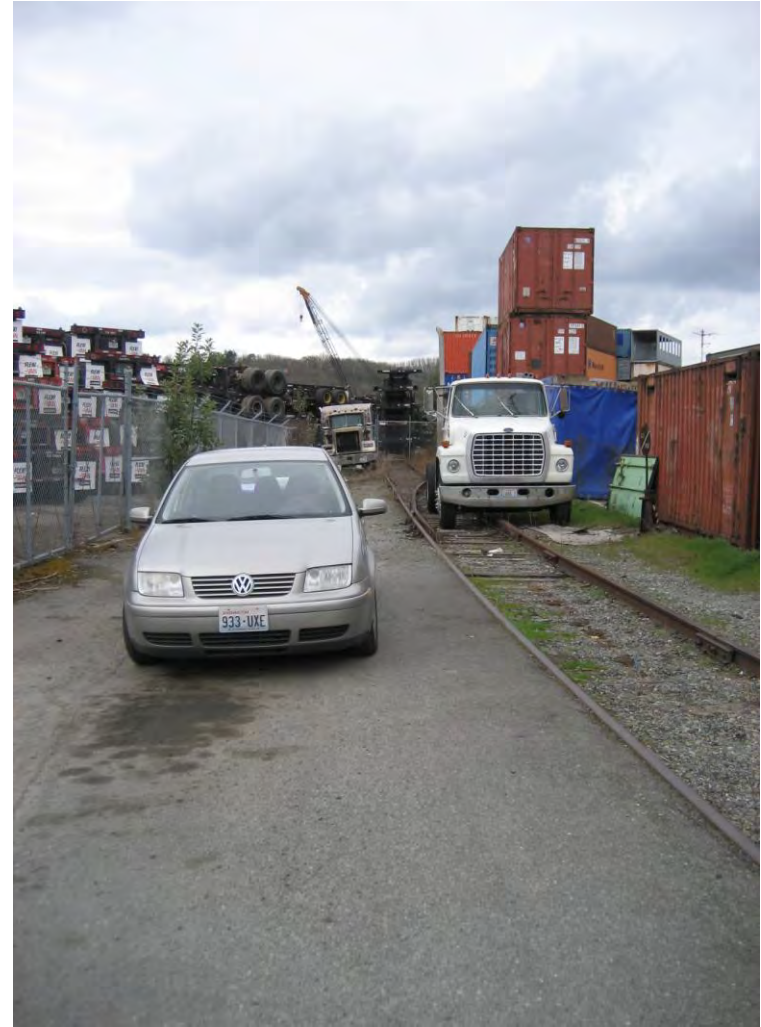
Photo 4: View (looking northwest from Diagonal Ave S) of the railway crossing the southern portion of the eastern parcel onto the eastern and central portions of the western parcel of T-108.

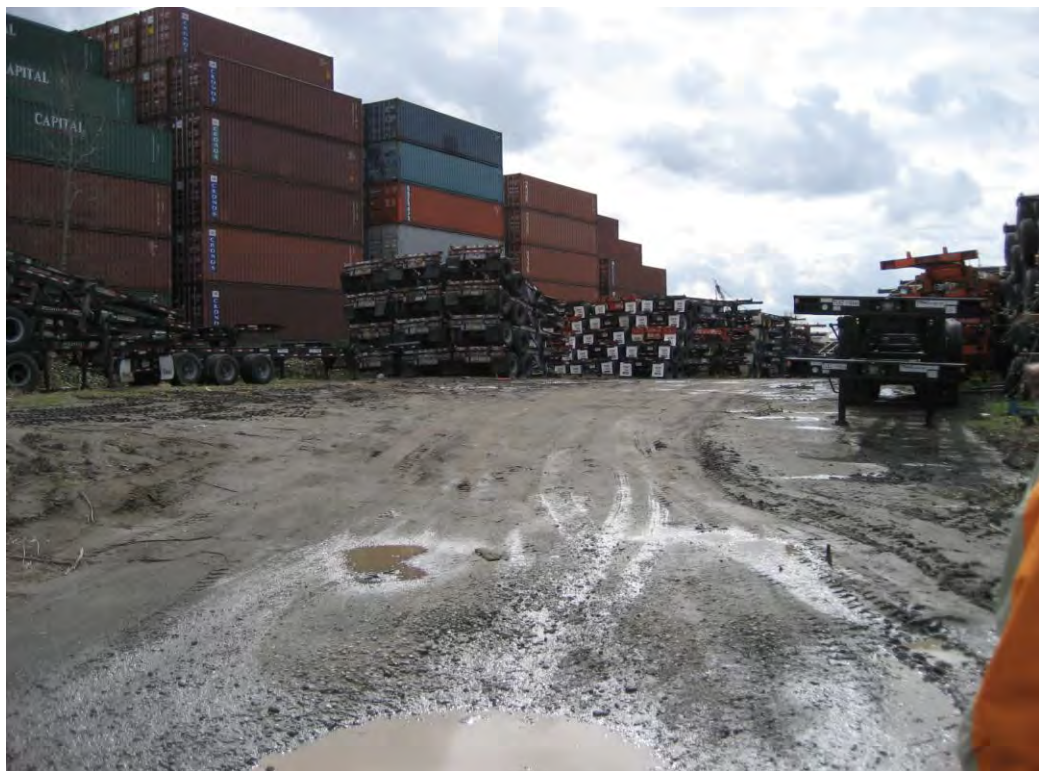
Photo 5: View (looking south) of the northern portion of the western parcel of T-108. Container chassis are stored on portions of this parcel. The containers in the background are located on the eastern parcel.

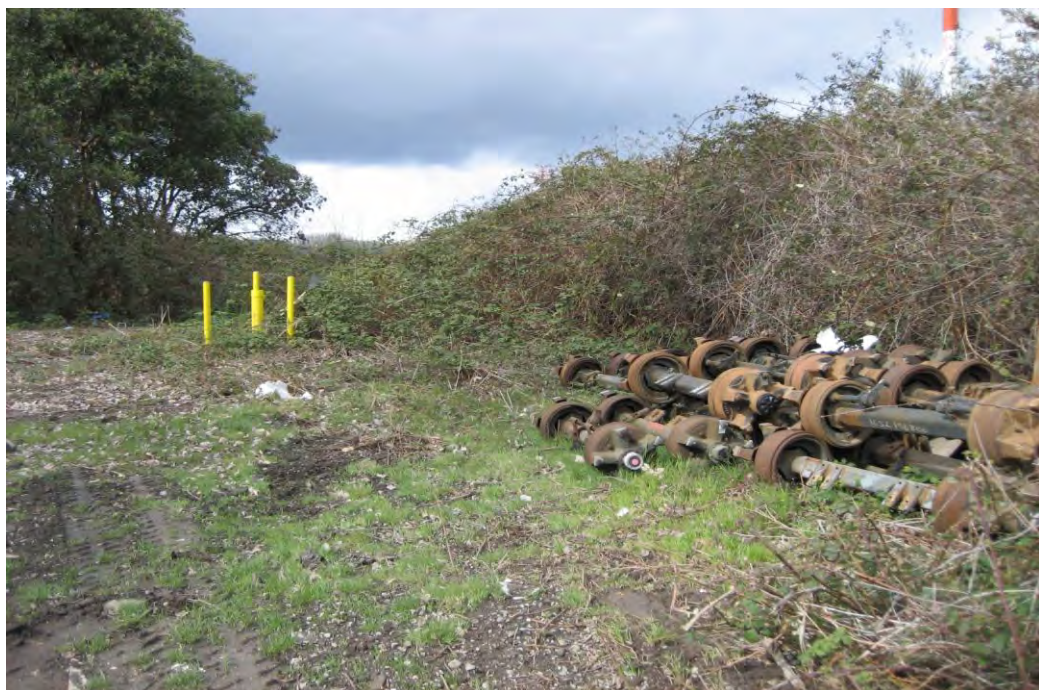
Photo 6: Vegetation, chassis parts storage, and a groundwater monitoring well (PGG-5) located on the northern portion of the western parcel of T-108.

The majority of the container yard on the Eastern Parcel of T-108 is paved, however some portions are covered with gravel (Map 2). The southern half of the Western Parcel of T-108 is paved or covered with gravel. The paved and graveled areas on the Western Parcel were formerly used as part of the Lafarge bulk cement terminal and as a parking lot associated with the Diagonal Avenue S STP (discussed in Section 3.5). Currently, a thick layer of soil covers much of the paved/graveled portion of this parcel, and ConGlobal uses some of the area for chassis lay-down and storage (Appendix A, Photos 5, 7, and 8). The majority of the northern portion of the Western Parcel is unpaved and is covered with vegetation including grass, low lying shrubs (predominantly blackberries) and trees (Appendix A, Photo 6).
