Port of Seattle
Terminal 108

Preliminary Assessment Report

February 2019
REVISED FINAL

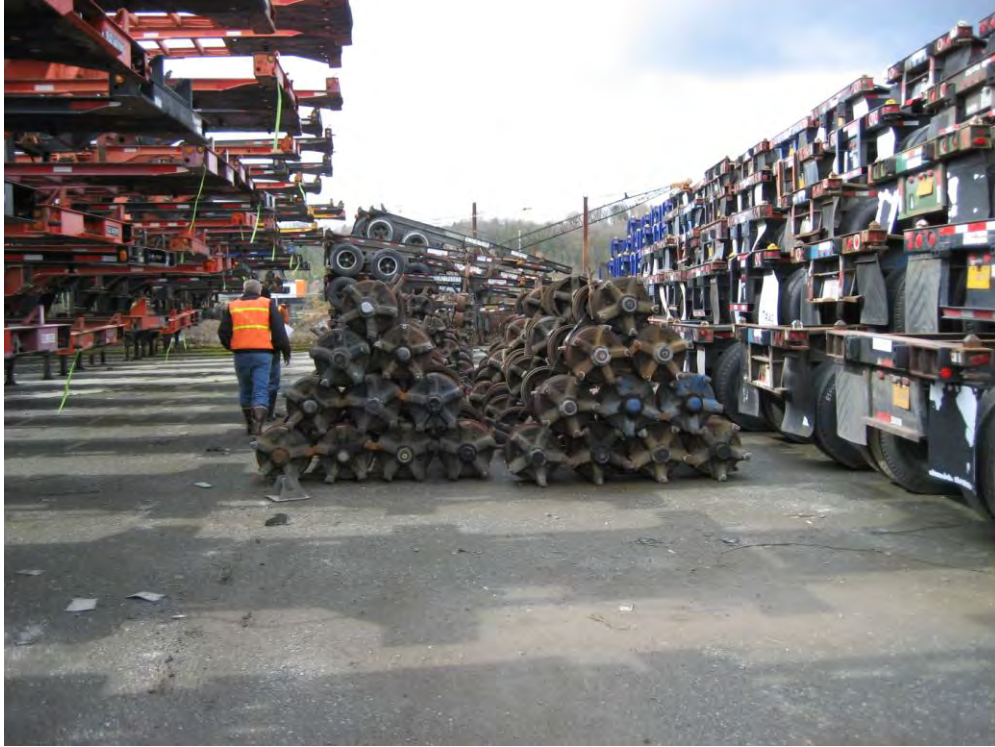
Photo 7: View (looking west) of the chassis storage area located on the paved, central portion of the western parcel of T-108.

ConGlobal also leases the majority of the Western Parcel for use as a chassis storage and lay-down area (Appendix A, Photos 7 and 8). The public access park and mitigation area remain on the southern portion of the Western Parcel and are not included in the ConGlobal lease area (Appendix A, Photos 9 and 10). For reference purposes, Map 8 provides a comprehensive presentation of the historical site features (presented on Maps 6 and 7) overlying the current conditions of the T-108 subject property. Map 9 expands this comprehensive presentation to include the locations of previous soil and groundwater sample locations.

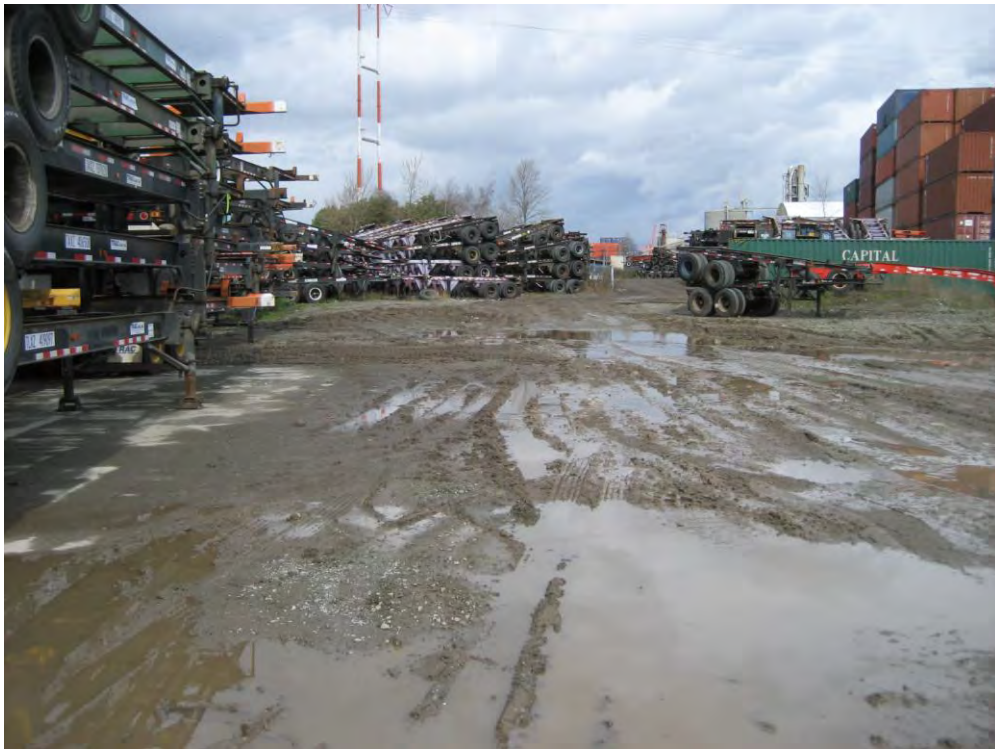
Photo 8: View (looking north) from the interior of the western parcel of T-108. High-power transmission lines located along the S Oregon St ROW are visible in the background.

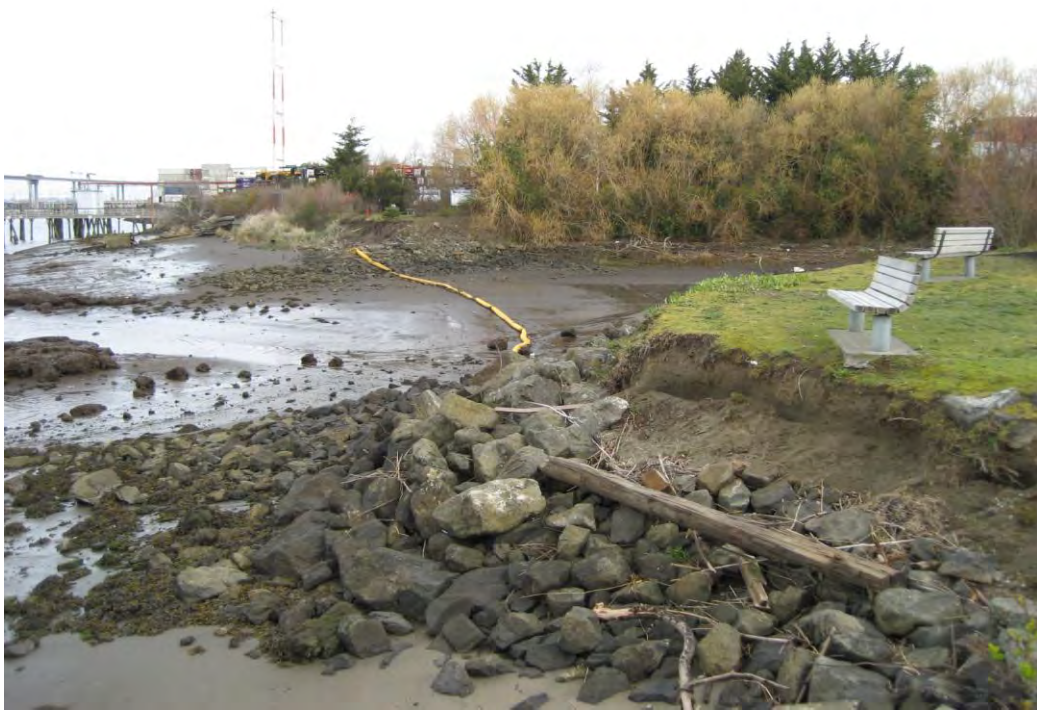
Photo 9: View (looking north from the Diagonal Ave S street-end) of the T-108 mitigation area and shoreline; protective buoy line visible at center of image.

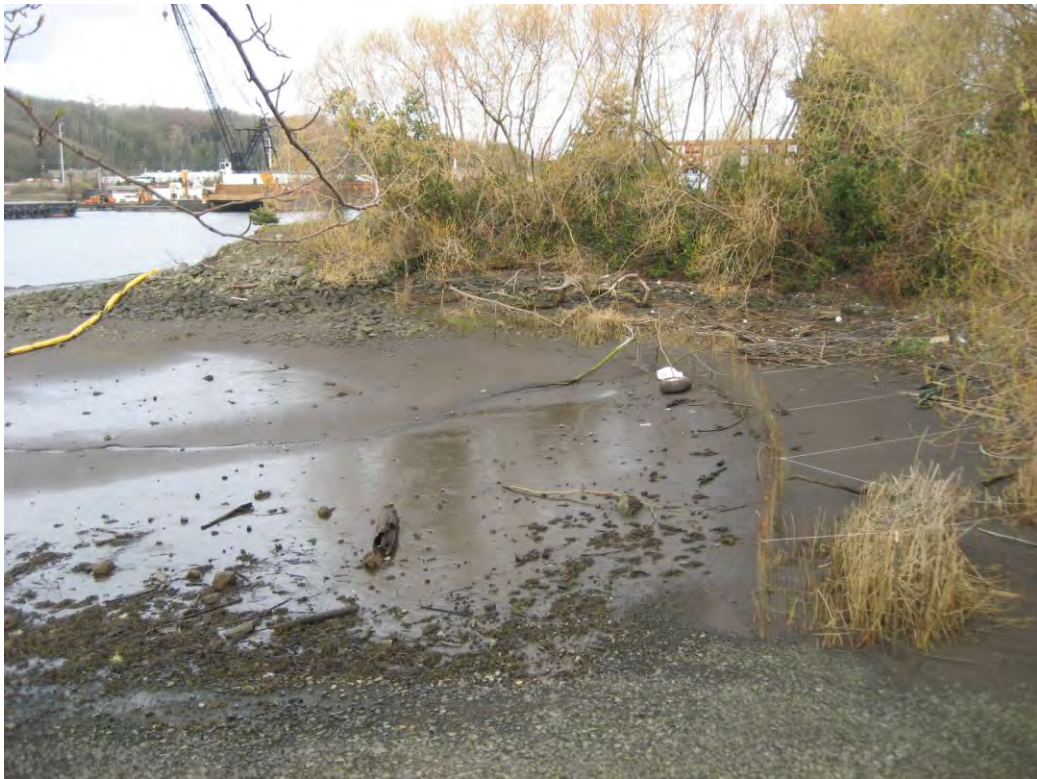
Photo 10: Close-up view (looking north) of the T-108 mitigation area.

The T-108 shoreline is approximately 1,200 ft (or 0.23 mi) long. The bank elevation of the northern and central portions of the shoreline varies from 0 to 10 ft (Port of Seattle Datum) (Port of Seattle 1993). The bank elevation of the southern portion of the shoreline, which includes the mitigation area, varies from approximately 4 to 18 ft (Port of Seattle Datum). The northern and central portions of the T-108 shoreline are armored with riprap, gravel, and other materials (Appendix A, Photo 15). Along the south-central portion of the shoreline, to the north of the mitigation area, the shoreline is partially armored with riprap and a wooden bulkhead which runs parallel to the shoreline. The bulkhead is not well-anchored and is slanted away from the shoreline (Appendix A, Photos 12 and 13). Within the park and mitigation area, the T-108 shoreline is primarily unarmored, with the exception of gravel (habitat mix) scattered along the perimeter (Appendix A, Photo 10).

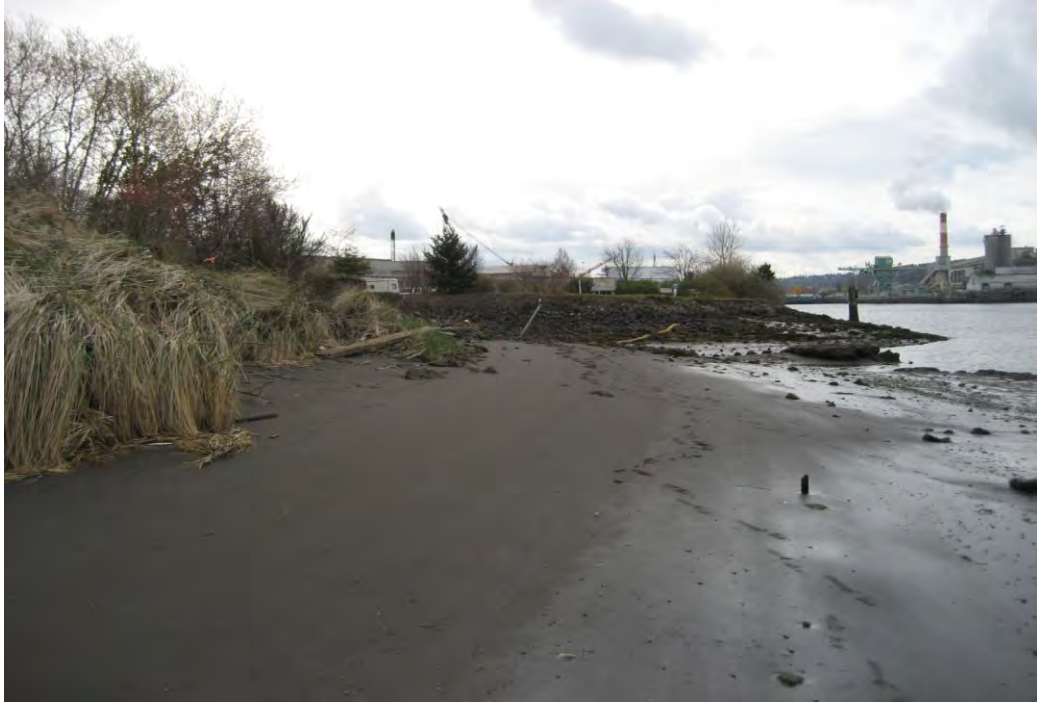
Photo 11: View (looking south toward the mitigation area) of the southern portion of the T-108 shoreline.

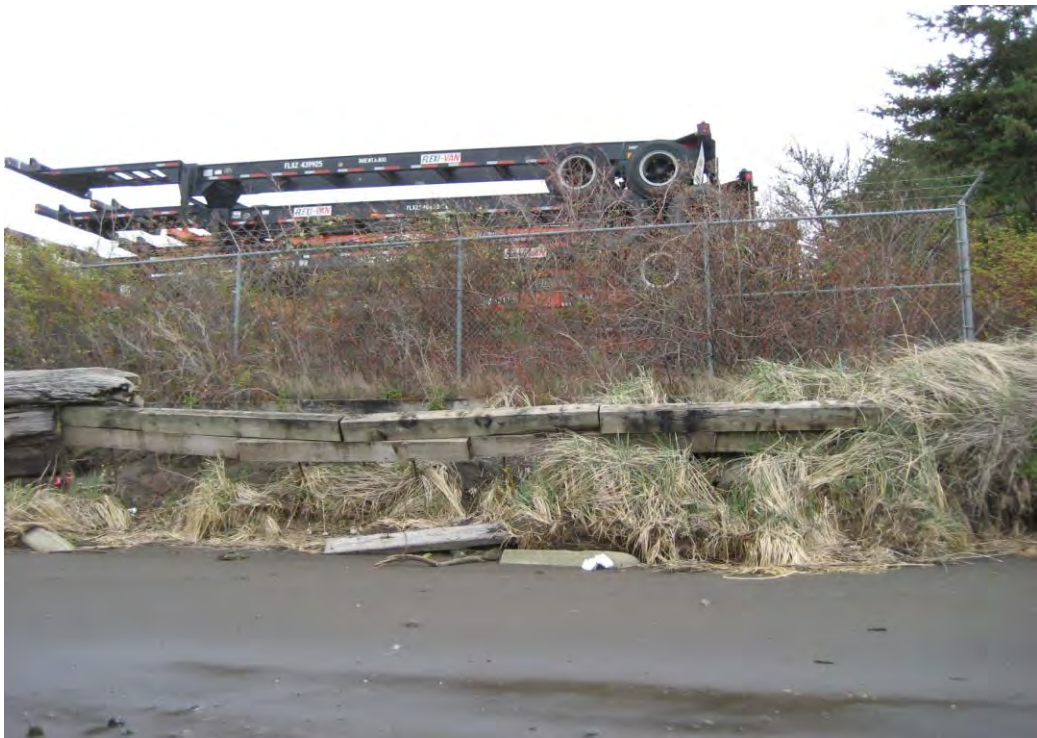
Photo 12: A portion of the wooden bulkhead located on the south-central portion of the T-108 shoreline.

accordance with the Port's public access plan (Port of Seattle 1985a) and included a trail and hand-boat launch area. The wooden bulkhead observed along the property shoreline in March 2008 were associated with the public access trail (Blomberg 2008) (Appendix A, Photos 12 and 13).

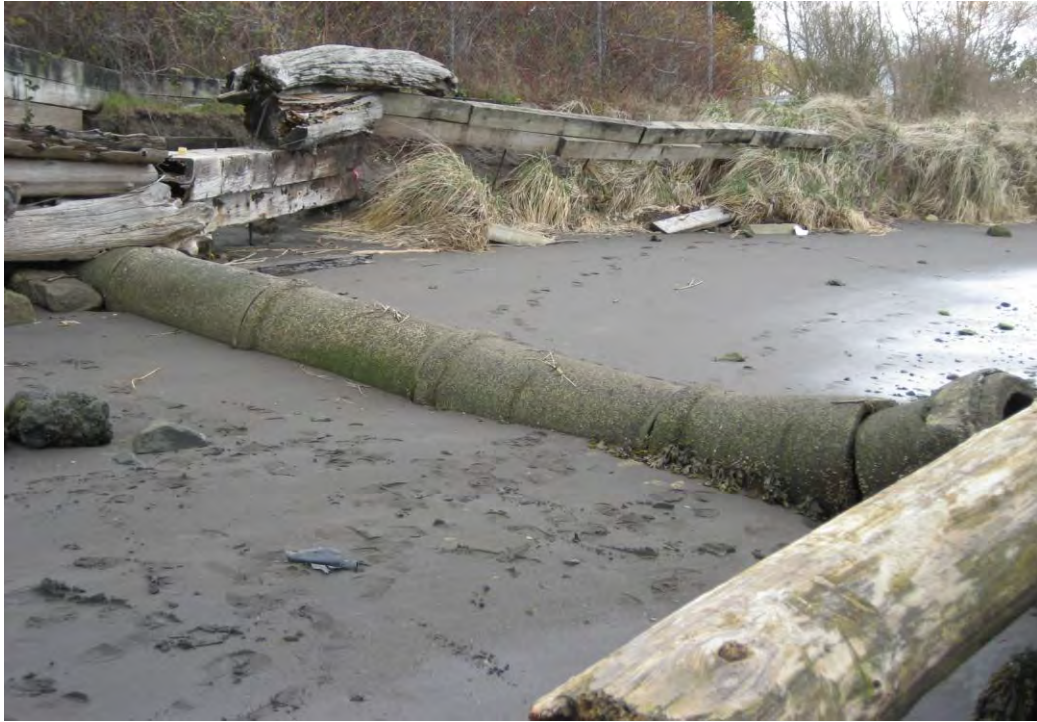
Photo 13: Wooden bulkhead and the Port storm drain outfall (2225) located on the south-central portion of the T-108 shoreline.

Two outfalls points are located along the T-108 shoreline boundary. One is an active storm drain outfall that drains the southern portion of the Western Parcel (Port of Seattle outfall 2225 on Map 2), located in the vicinity of the wooden bulkhead (Appendix A, Photo 13). The second is an abandoned outfall formerly associated with the Diagonal Avenue S STP, located to the north of the active outfall (former Diagonal Avenue S STP outfall 2002 on Map 2; Appendix A, Photo 14). In addition, a wooden box frame structure in an extreme state of disrepair was observed in approximately the middle of the shoreline. The former purpose of this structure is not known.

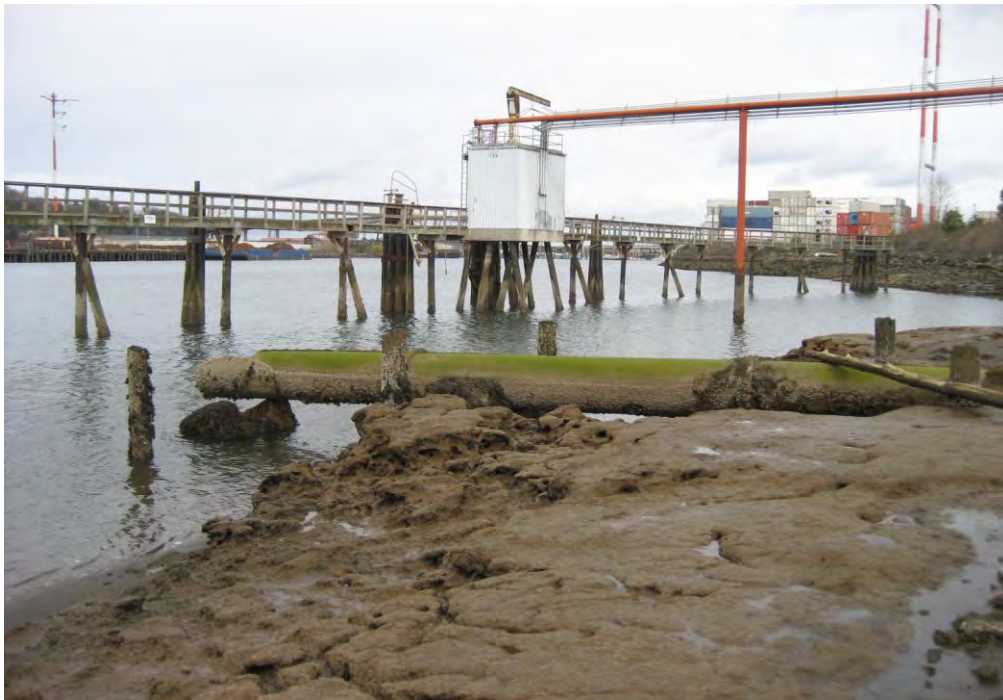
Photo 14: View (looking northwest) of the abandoned Diagonal Ave STP outfall and the pipeline dock (installed by Lafarge) located on the north-central portion of the T-108 shoreline. Note the native intertidal substrate.

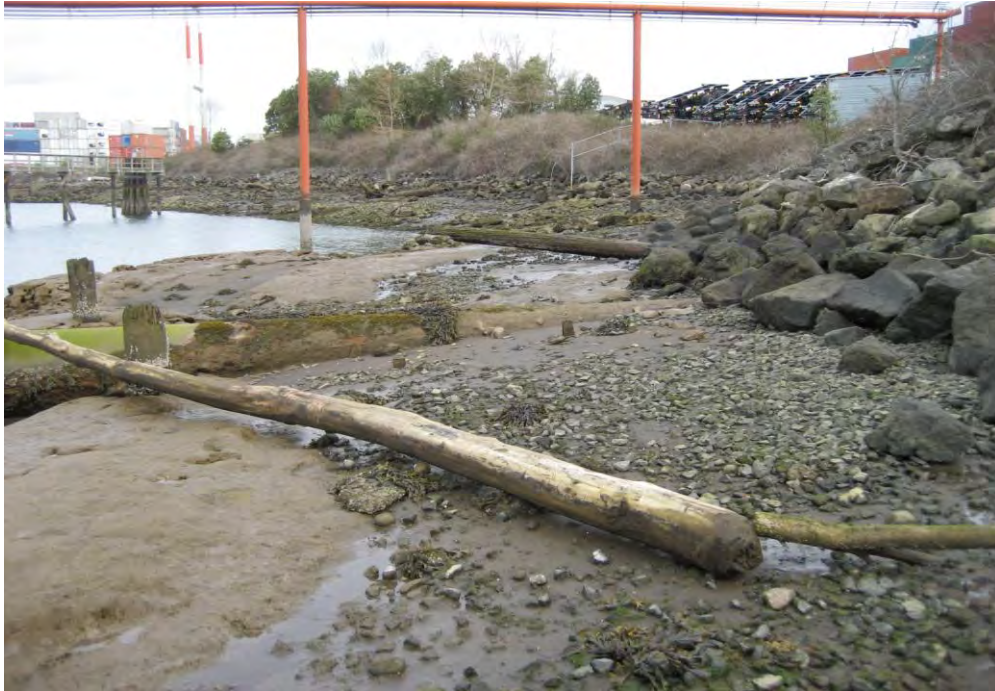
Photo 15: View (looking north) of the north-central and northern portions of the T-108 shoreline; the bank in this area is armored with rip-rap.

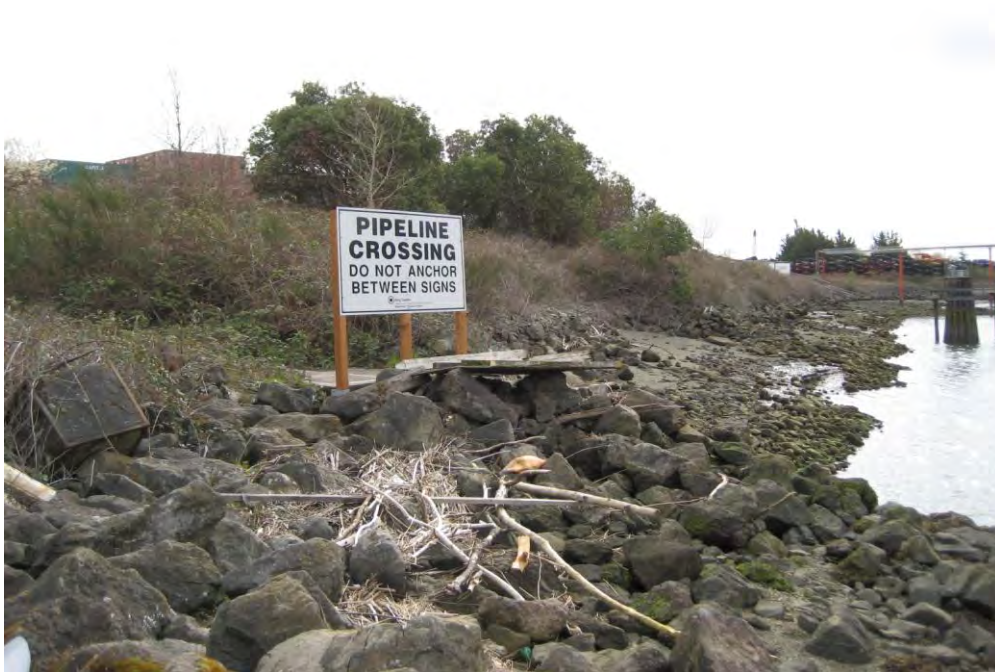
Photo 16: View (looking south from the S Oregon St ROW end) of the northern portion of the T-108 shoreline. The Duwamish/Diagonal CSO/SD and EOF outfalls are nearby, and the location of the Duwamish Siphon is indicated by the sign.

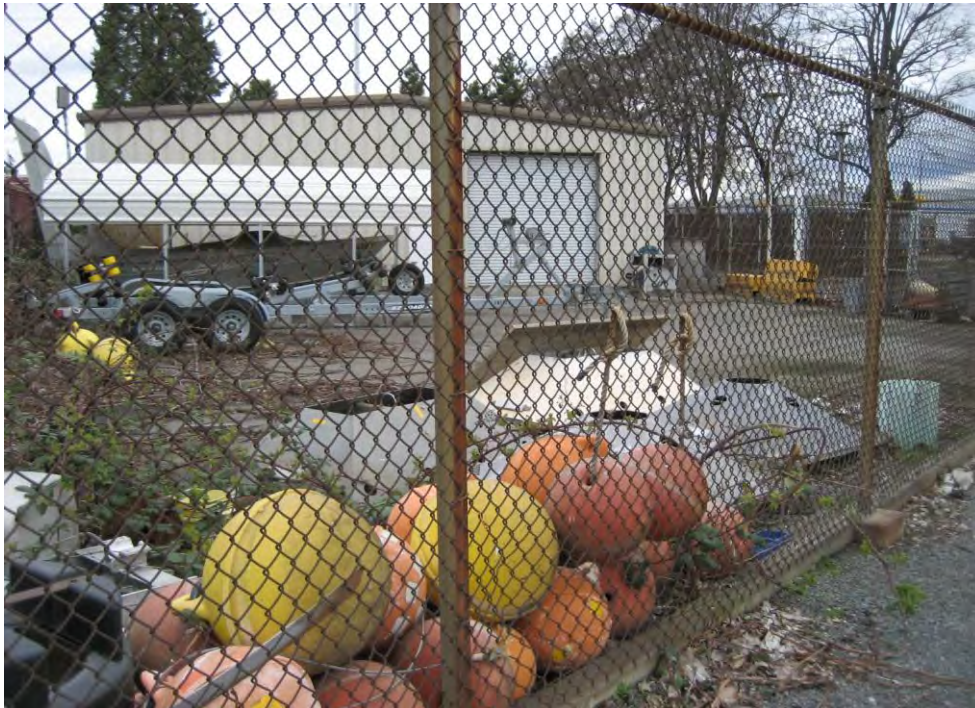
Photo 18: View (looking northeast from Diagonal Ave S) of the King County pumping station located adjacent and to the east of T-108.

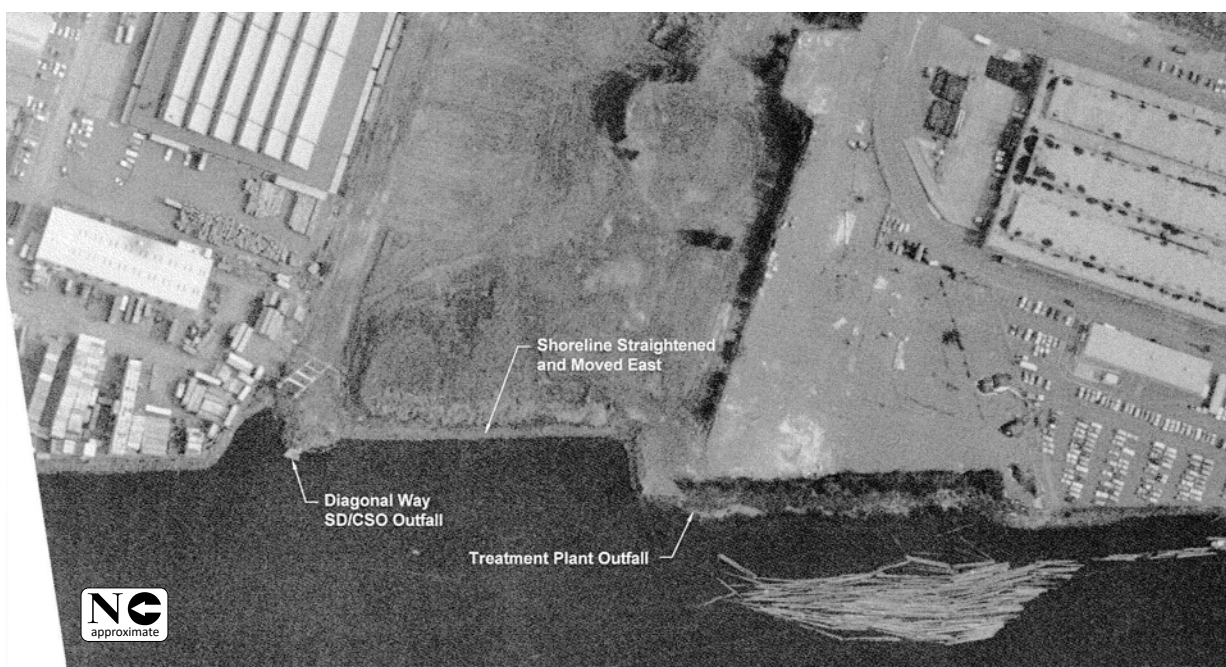
1977 aerial photograph showing settling holding pits filled (KCDNR et al. 2005; photograph provided by US Army Corps of Engineers, Seattle District, dated October 4, 1977)

As summarized in the ECR, and confirmed in documentation provided by the USACE in response to the FOIA request, two cleanup actions occurred. In 1974, USEPA completed the initial dredging operation, but it was found to be incomplete, only recovering 80 gallons of the estimated approximately 260 gallons spilled. In 1976, the USACE completed additional hydraulic dredging of sediment from Slip 1 and the LDW, recovering another 170 gallons spilled, and dewatered the resulting slurry in the upland area of the Site (USEPA 1977). Chiyoda, the property owner at the

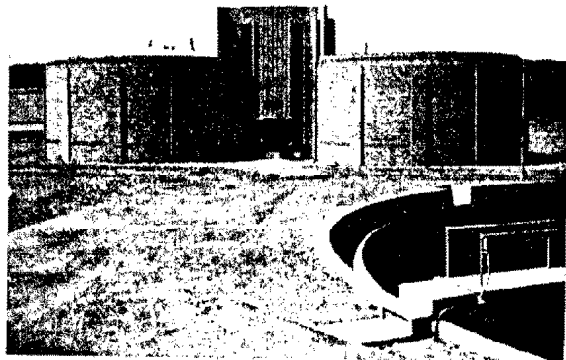
DIGESTER GROUP, AND PART OF CLARIFIER AT RIGHT

The digested sludge will be drawn off by gravity to four sand beds 40 by 100 ft, three of which are glass covered, to facilitate drying during periods of inclement weather. As the flow approaches the design quantity,

it is expected that two sand beds will be added and all will be glass covered. Provision is made for mechanical ventilation of sludge-drying houses if this is found to be necessary. Dried sludge will be loaded by hand onto a caterpillar tractor with side saddles and used for fill on the site or as a soil conditioner.
